MARYLAND HISTORICAL TRUST DETERMINATION OF ELIGIBILITY FORM

Maryland Inventory of Historic Properties Addendum

F-2-46 (see also Site No. 18FR932)

Benjamin Rice Mill; Parker's Mill, Mountain Mill, or (current)

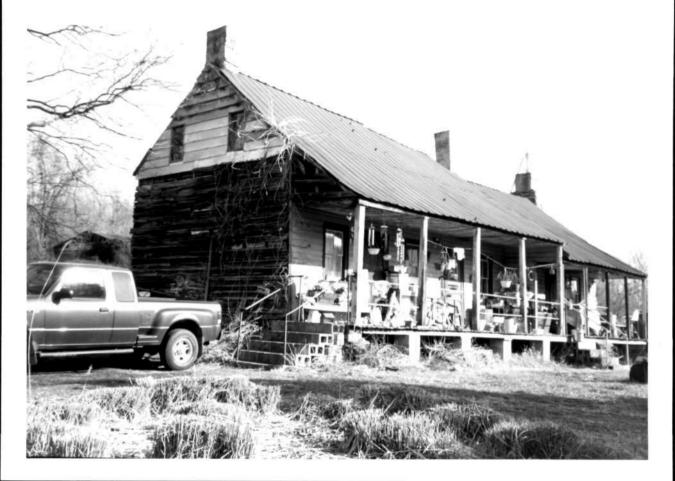
F-2-46 BENJAMIN RICE MILL- FELL'S HOUSE Frederick Co., MD. ARRUSER 2/2008 MADSHED LOOKING AT SOME (MININ) FROMDE From SouTh DEST 1/21

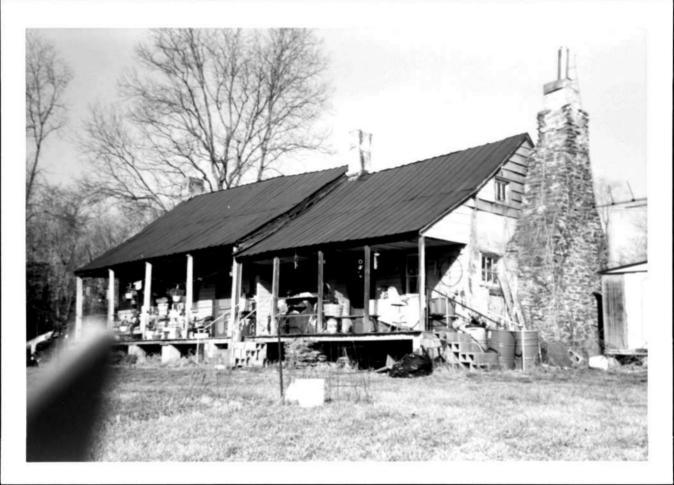
F-7-46 FEWIAMIN RICE VMUL-FORLIS HOWAL FRETERICK CO, MD. ABRINGE 4200 VINDSNPO. LOOKING HT SOUTH FACHE FROM SOUTH SUST

House: The dwelling at the Benjamin Rice Mill is an example of a double pen building. The western portion has a center hall with one window on either side of the entrance. A second entrance is immediately to the south and it is paired with a window to the south and what is now an interior chimney that may have been exterior at one time. The double front entrance suggests that the smaller room was used by the public and the mill owners for conducting mill business. South of the main pile is an attached kitchen wing with a center entrance and one window on either side of the door. An exterior stone chimney is attached to the south wall. The stones of the south chimney are uncoursed rubble. Each chimney has been repaired, and appears to be either whitewashed or stuccoed. The exterior of the dwelling is clad in logs, but in some areas these have been covered over with German weatherboards, stucco or vinyl siding. The house has a recent side gable, standing seam, metal roof that has been extended to make a shed roof over the front porch. The porch extends across the front façade of the building, and the roof is supported by unadorned square posts. The windows are two over two sashes with smaller fixed windows in the second floor. The building sits on low stone piles or

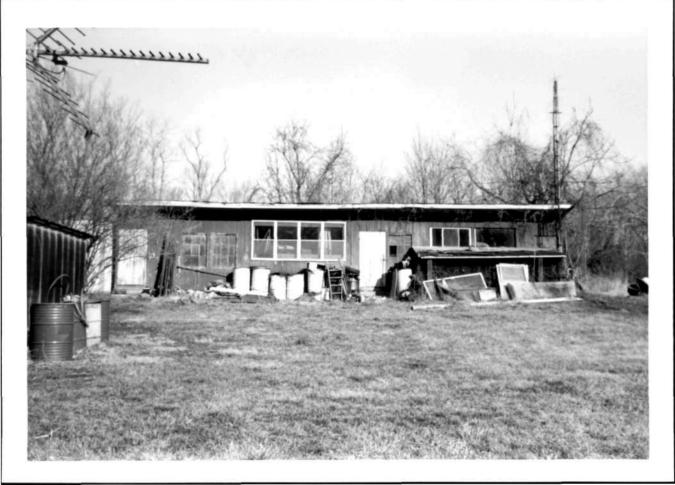
F-Z-46 FENJAMIN RICEVIILLY SAKED #1 FREDOCICK.CO., MD A Bringer 2/2008. MND SAPO LOOKING NORTH AT SHOOT SONA FROXE 3/21

Outbuildings: To the southeast of the dwelling are three outbuildings. Two have shed roofs while the third has a front gable roof. All three are wood frame and clad in vertical siding or clapboards. The largest of the sheds has a series of windows and a panel door. The middle shed has a door with four lights in the upper portion. The third shed has a sliding door. Each appears to be used for storage, but may have functioned as a stable, hen house, or other small domestic outbuilding.

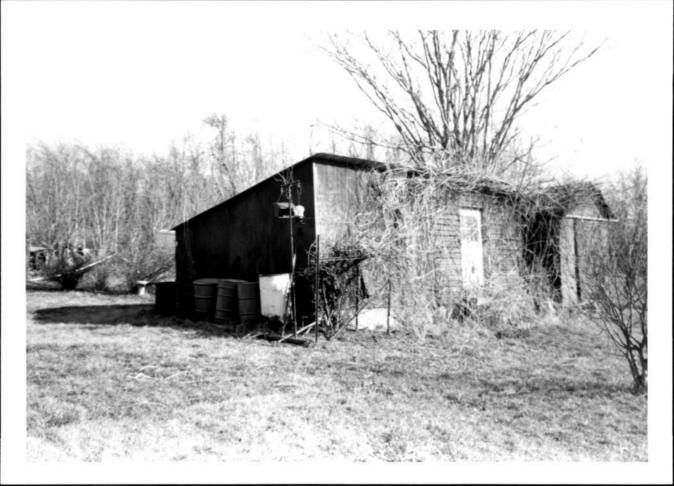
F-Z-46 BENJAMIN RICE MILL-SHEDS ZG 3 FREDERICK CO., MD A. BRINDER. 2/2008 MD SAPO LOOKING NORTH EXET AT SOUTH FACADES OF SHEDS ZQZ

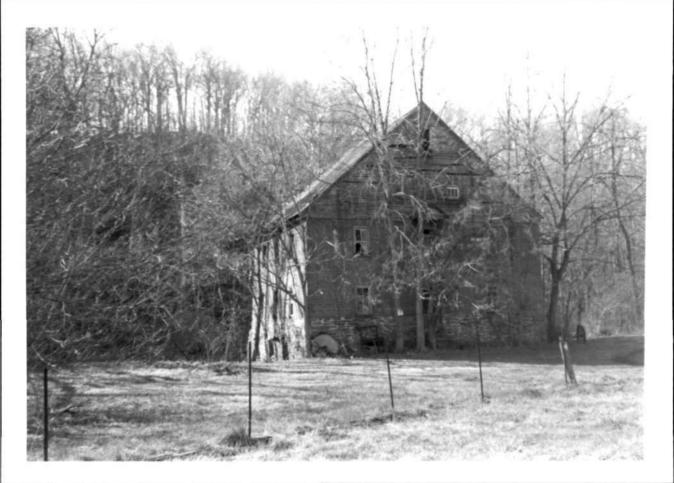
F-2-46 ENJAMIN TICE MILL MILL EMILDING FREDERICK CO., MD. A. BENDER. 42008. MDSAFO. LOCKING AT LOCKETH FACKAGE OF REELI'S VMIL

Mill Building and associated features: In addition to the description provided in 1991, the site still retains many features of the mill. The mill is square and has three bays on each wall. It has a stone ground floor, the first and second floors are clad in brick, and the gable ends are of weatherboard. In the two gable walls, there are two windows at the attic, but one window in the peak of the gable. The brick is laid in a pattern that the Frederick City architectural context states was typical of a bonding pattern found there from the late eighteenth century to 1820. The pattern is three rows of stretcher bricks, topped with a row of headers. The mill has an attic and a basement as well as two floors which were used when the mill was fully functioning. Grain would be cleaned in the attic after being lifted up from the main (first) floor, while the other equipment would be placed in the ground floor at the same level as the waterwheel. The mill dam is located approximately 1,000 feet north of the mill on the north side of the MD 464 Bridge. It is a rock dam that has collapsed somewhat over time. An 1880 advertisement states that the mill dam had a 10-foot fall, and photos from 1933 show some of its features. There is exposed wooden cribbing that is part of the dam framing on the north side of the bridge. When the MD 464 Bridge was constructed in 1933 and 1934, the State Roads Commission constructed two concrete retaining walls and affixed the sluice gate to the one attached to the east bridge abutment. Water was channeled between Pier D and the creek bank into the head race. The head race remains parallel to the creek along its east bank. It is somewhat overgrown, but very evident. The mill pond and wheel pit are present on the creek side of the mill and a tail race extends back to Catoctin Creek south of the mill. The stone wall between the wheel pit and the tail race has an arch that allows the water through it. Although SHA was not allowed into the mill structure, it appears from the outside that much of the milling machinery is present. McGrain notes an advertisement from the American Miller dated April 1, 1880, which described the millwheel as an overshot wheel that was 9 feet broad. A large millstone is leaning against the structure facing the house (this stone may not be original to the Rice Mill. On

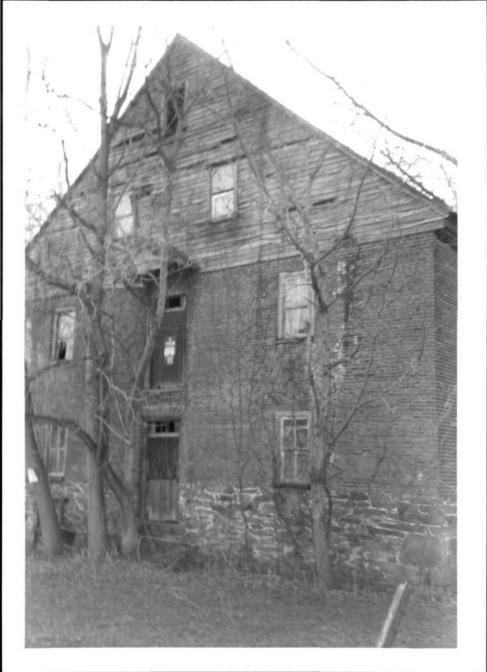
F-2-46 Fanjamin Rice MILL-MILELLE. FREDERICK CO., MD A. BENDER. 7/2008-MDSARO. LOOKING, SOUTH EXET AT BELL'S MILL 1 DETRIFACTOR

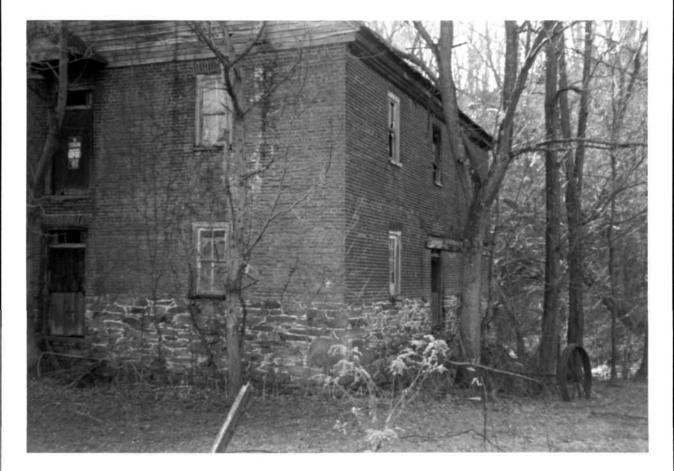
F-Z-46 RENJAMIN RICE MILL MILL POLE, FREDERICKCO, MD. A. FORUMET. 42008. LUD SHPO. LOOKING OF NORTH & WEST FACTORS

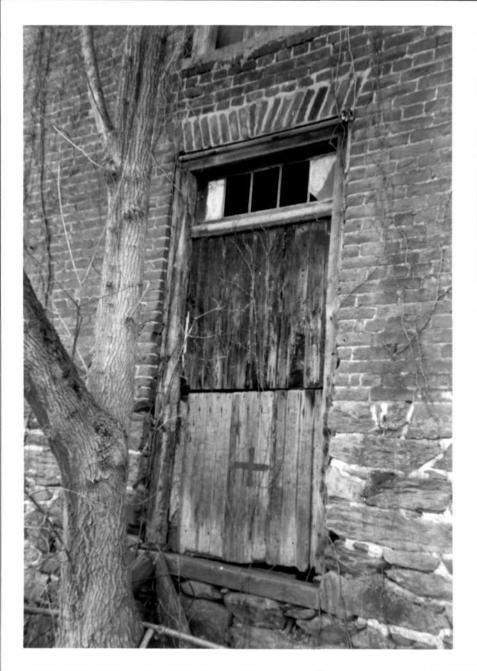
F-2-46 RENJAMINDRICE MILL- MILL BUSE. FREDERICK CO., MD. A. PERMEEL 42008. MOSAPO LOOKING AT NORTH DOOR PALLES Mile 8/21

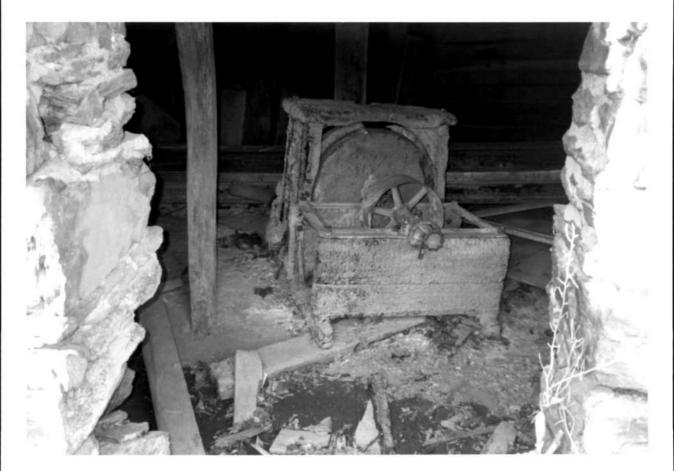
F-2-46 FENJAMINTRICE VIIIL- EGLIPMENT. FREDERICK CO., MD A. PSRINDER 2/2008. MDSARO. LOOKING, AT EQUIPMENT IN PASSENSAT

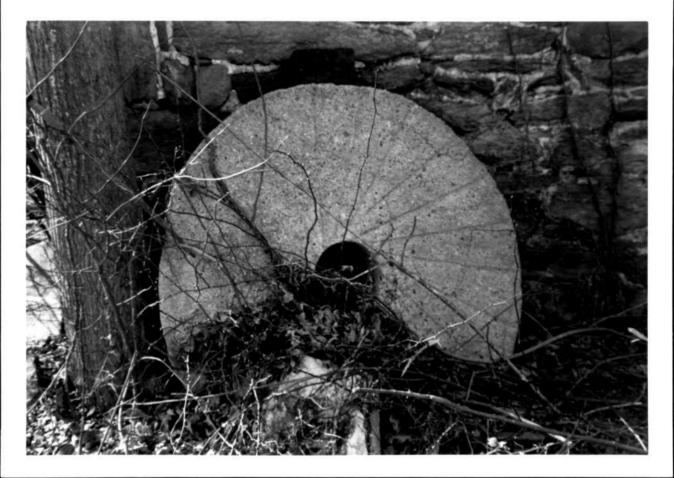
F-Z-4 PENJAMIN TZICE VMU-10HEEL. FEEDERICK CO., MD A. Bronser 2/2008 MD SARO. LEEKING COUTHAT MULTONE AGAINST NORTH FACIDE

February 11, 2008, SHA staff spoke to Mrs. Hanson, the owner of the Lewis Mill, who indicated that Mr. Charles Bell worked at the Lewis Mill in the 1960s and 1970s and took equipment away from it for his mill. John McGrain first photographed the mill stone outside the mill in 1973, and it remains there thirty-five years later.) There are several descriptions of the mill building in John McGrain's *Mollinography of Maryland* (2007), Davis' 1991 MIHP form and a new book about milling near Brunswick in Frederick County, *In Search of Our History: The Water-Power Flour and Grist Mills of the Brunswick Region*, by Peter Maynard (2004). Although written at various times in the past thirty years, the descriptions do not vary, and this reflects the limited access historians have been granted to the property. The Rice Mill was closed in the early 1960s, and as a result of the abandonment and disuse, the building is falling into a ruinous condition. The Bell family members continue to live on the property.

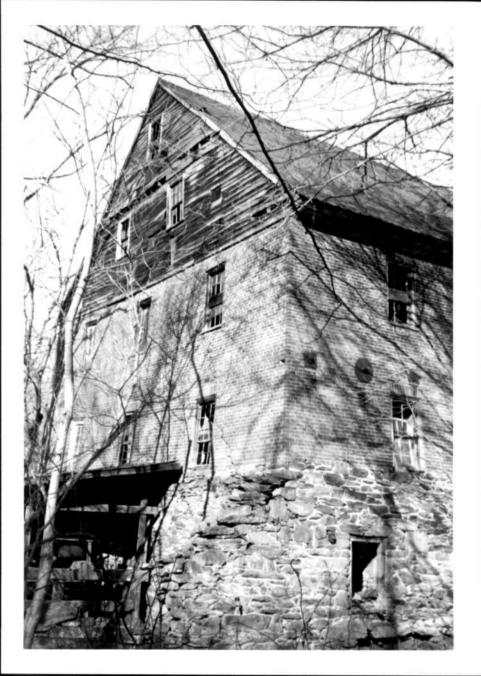
F-2-46 BENAMIN RICE MILL- VMU FULG. Frederick Co., MD. A. FRENDEZ 2/2008 MD SAPO. LOOKING NORTH WEST AT SOUTH 2,5x5 FACADES

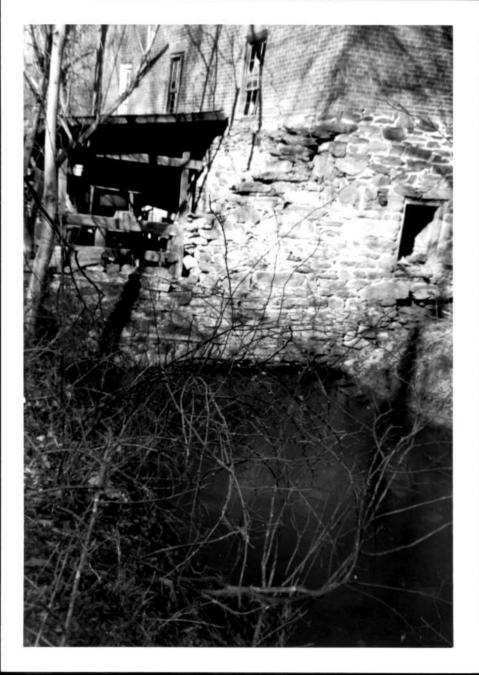
F-7-46 BENJAMIN RICE MILE-MILE FILE. FREDERICK CO., MD A. PRINDEZ 2/2000. MDSAPO LOOKING WEST AT TAIL BACE

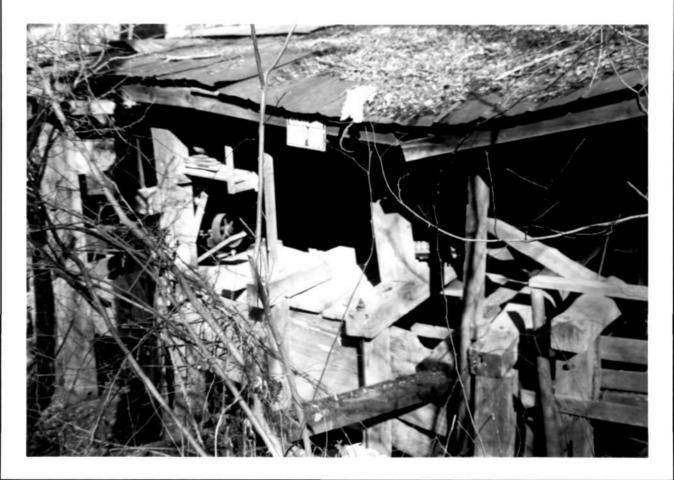
F-Z-4K BENJAMINO ROCE MILL CHEEL HOUSE YZCEF (COULAPSED) FREDERICK CO., MD A. BRIDER. 2/2008 MOSAPO. LOOKING SOUTH AT WHEEL'S 1000 13/21

The building is roughly rectangular in shape with its ridge running north-south. The walls are laid in 3-course American bond. The west elevation has a center entrance with a Dutch door of vertical boards and a 5-light transom. The missing one-story porch sheltered the door and the south window bay, perhaps connecting with the frame structure on the south elevation which is now in ruins. The windows on the first story are 6/6, with gauged brick arches. The second swindows are 9/6. The raised stone foundation extends to the sill level of the first floor windows. A box cornice terminates the wall at the gable roof of standing seam metal. The north elevation reveals the german sided gables of the mill. On this elevation, there are two bays with a loading door in the center of the second story. A mill stone rests near the foundation on this elevation. The east elevation gives the clearest view of the race as it enters the base of the mill through a round stone arch. The race is still filled with water, but does not flow and the top of the arch is barely visible above the water level. The south elevation, as stated, has the ruins of a frame structure which apparently sheltered the wheel.

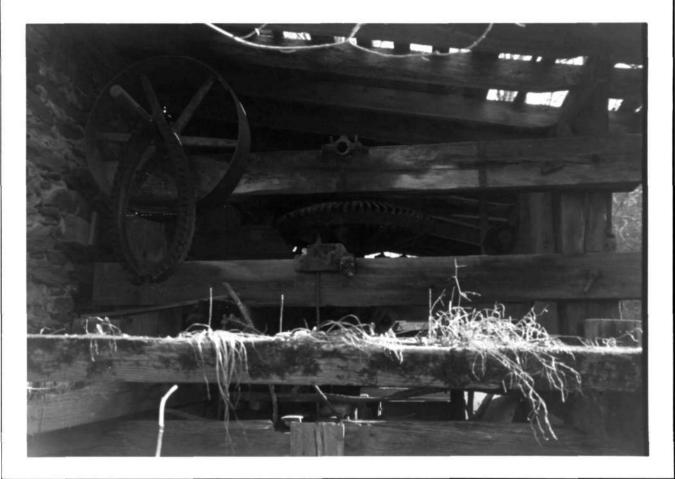
F-2-4 ESUJAMIN RICE MUL- MILL EGUIP-MEST FEEDERICK O, MD. A. BRUDER. 1/2008 VND SAPO. COOKING EXTT AT MILL GENES

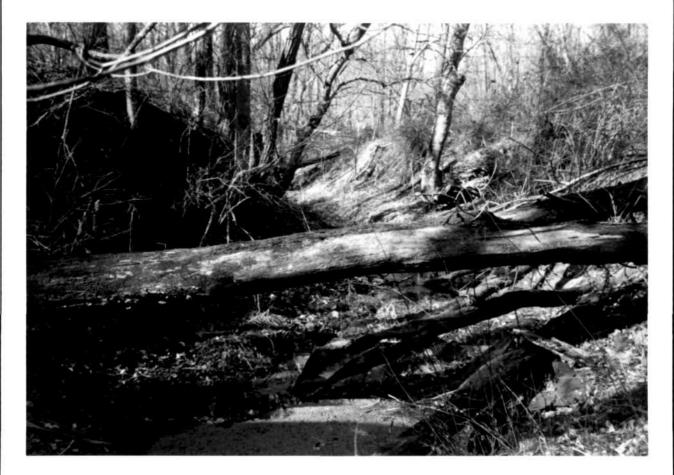
F-2-46 BOULAMIN PACE MILL HEAD PACE FEETERICK CO., ND A. Facentee 2/2008 WYDSHPO. LOOKING WEST AT MILL BACE

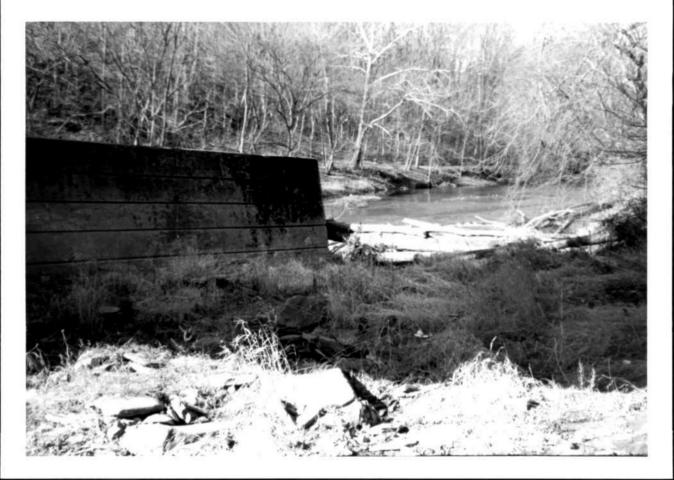
F-7-46 BEN AMIN'S RICE, MILL-SLINCE, OR HEAD BYCE GATE TETAING WALL FEEDERCO MY A. PRINTER. 2/2008 MD SARO LOOKING LESS AT MILL'S RETAIN ING UAULAT SAR BRIDGE. 16/21

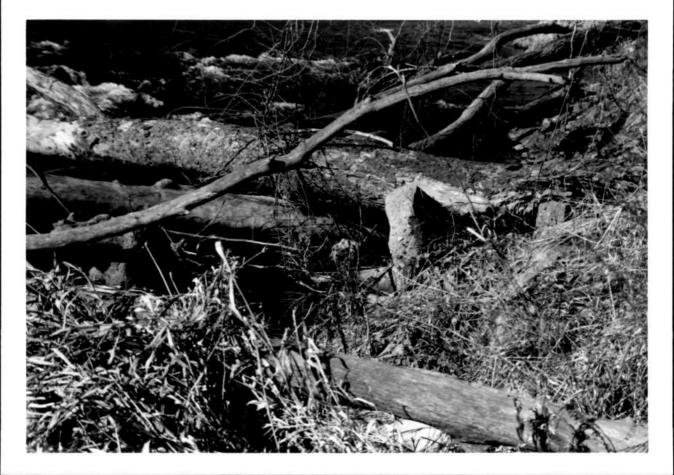
F-Z-46 PENIAMIN RICE-AMU- HEAD BYCE. GATE DETAINING WALL. FREDERICICO, MD. A BRINDER 2/2008 MDSAPO LOOKING NORTH AT DEMAINS OF WHO DURNIEZ STAD

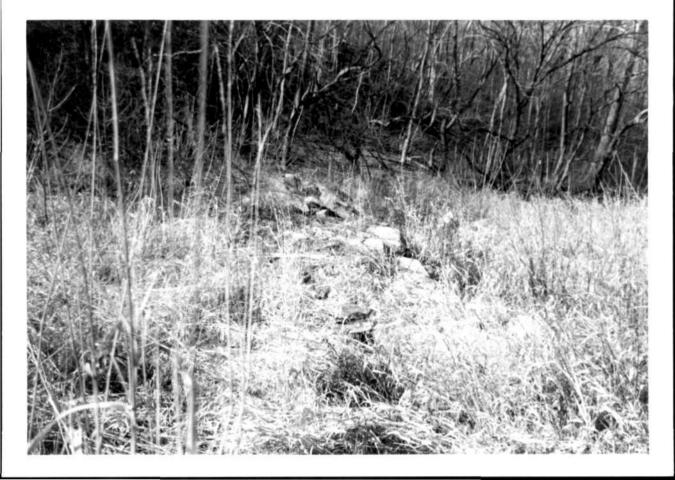
F-Z-46 BENJAMIN TRICE MILL - MILL DAM JEMINS. FREDSYCKO, ND A. Parender 42008 MOSARO LOOKING SOUTH AT MILL DAM

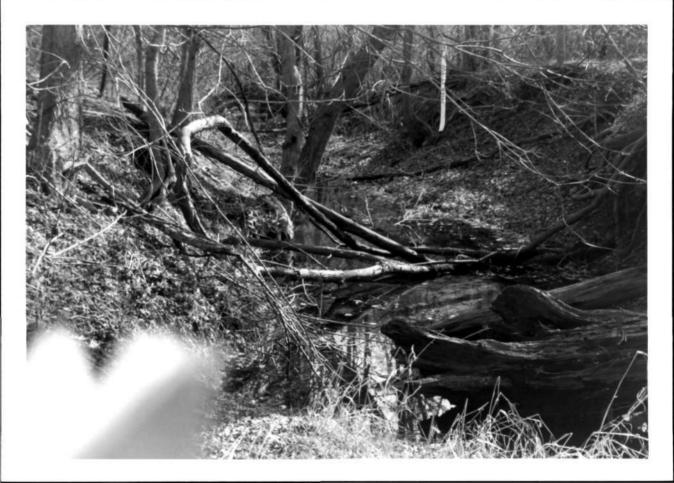
F-2-4 FOU JAMIN PACE MILL - HEAD BACE. Fressacklo, MD. A. FAZINDEZ. 2/2008 MD SAPO. LOOKING SAFT AT YMUL BAGS

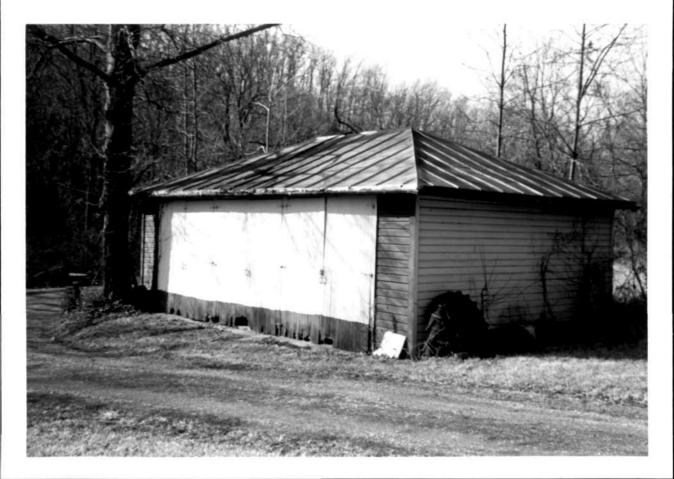
F-Z-46 BOUJAMIN RICE MILL - BARAGE/OMBYR FREDERICK CO. MID A. PARNIEC 2/2000 UNSAPO. LOOKING, NORTH AT GARAGE

<u>Hip roof building:</u> At the base of the hill, northwest of the mill is a three-bay hip roof building with three entry doors and a standing seam metal roof. The cladding is German siding, and the building is one story tall. It appears to be an early twentieth century garage.

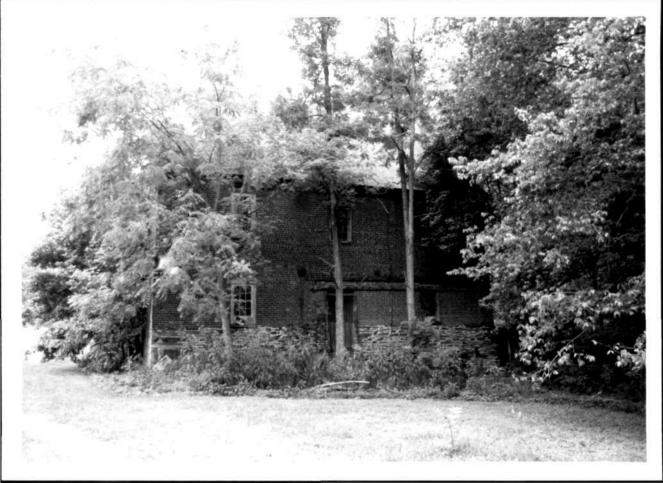
F-2-46 Benjamin Rice Mill Frederick County Photo: Janet Davis August 1991 Neg. loc. : Md. SHPO, Crownsville, Md. West elevation

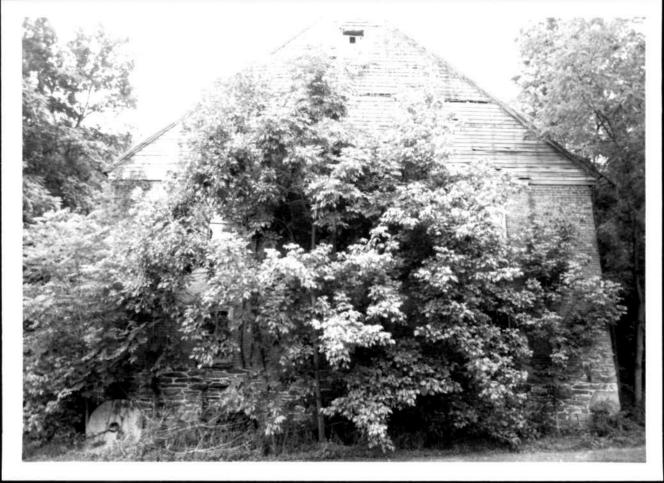
F-2-46 Benjamin Rice Mill Frederick County Photo: Janet Davis August 1991 Neg. loc.: Md. SHPO, Crownsville, Md. North elevation

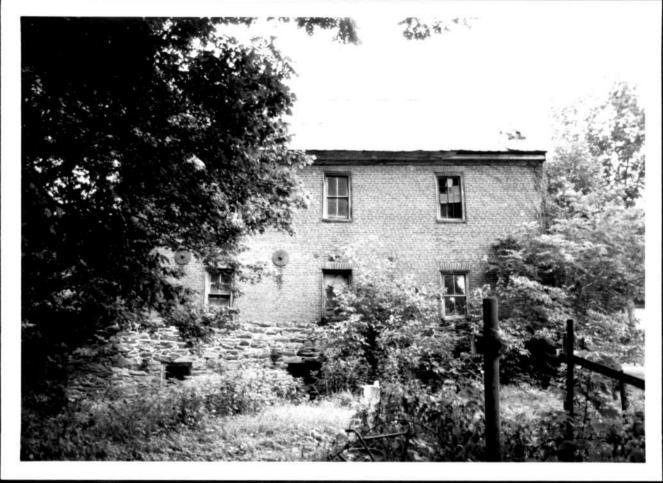
F-2-46 Benjamin Rice Mill Frederick County Photo: Janet Davis August 1991 Neg. loc.: Md. SHPO, Crownsville, Md. East elevation 3/3
